## Top Reasons Sprinkler System Installations Fail Inspection

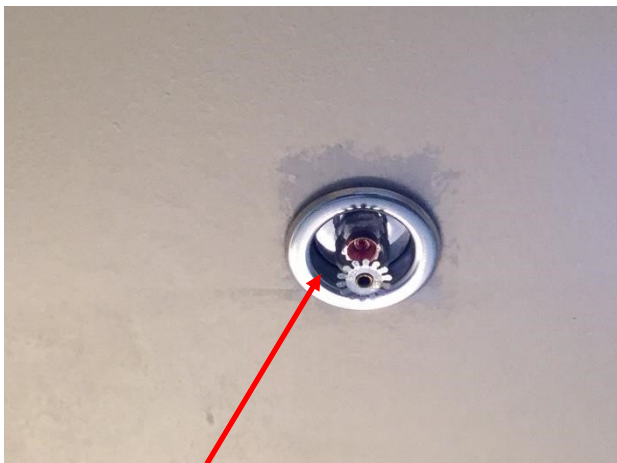
Semi-recessed head with less than 1/2" clearance below the ceiling surface

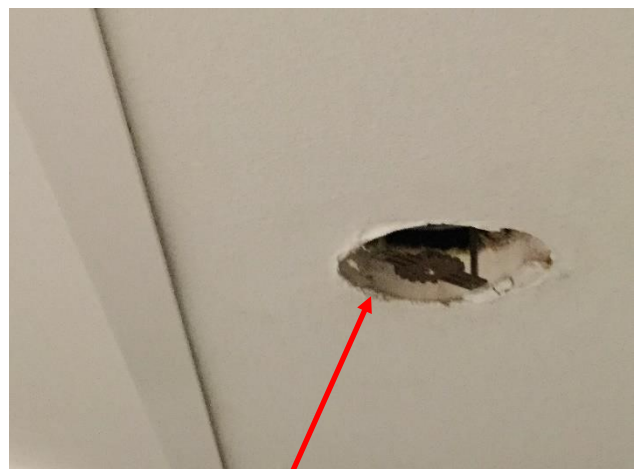
Concealed head with no clearance below the ceiling surface

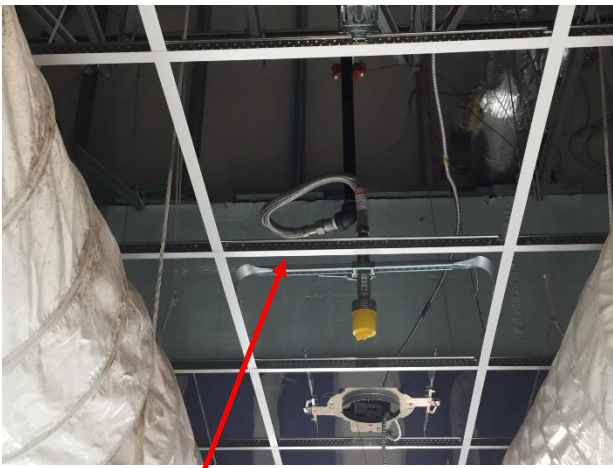
Failing to maintain the 4" minimum radius & number of bends allowed for 2' hose in violation of the U. L. Listing

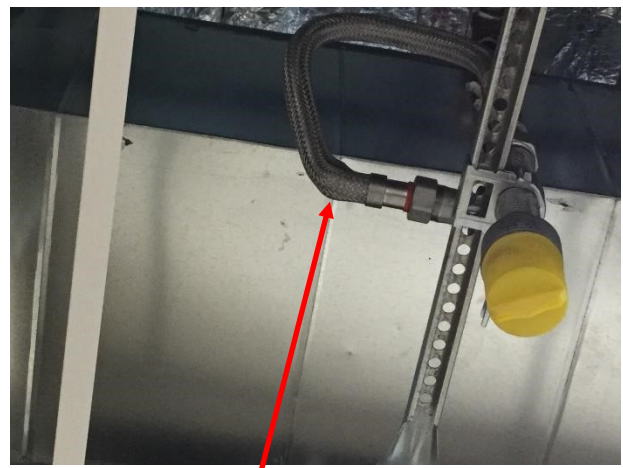
Crimped the hose during installation to achieve center tile

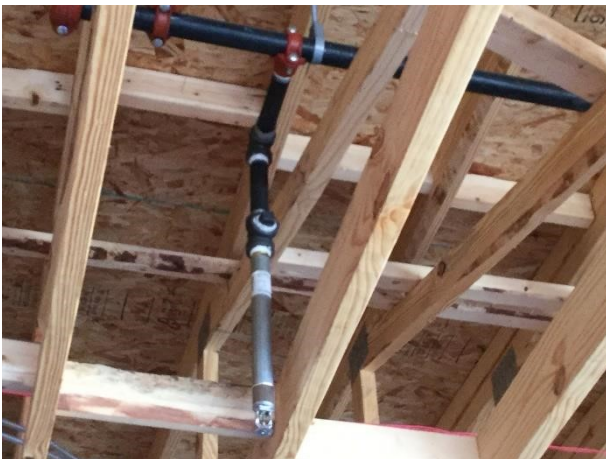
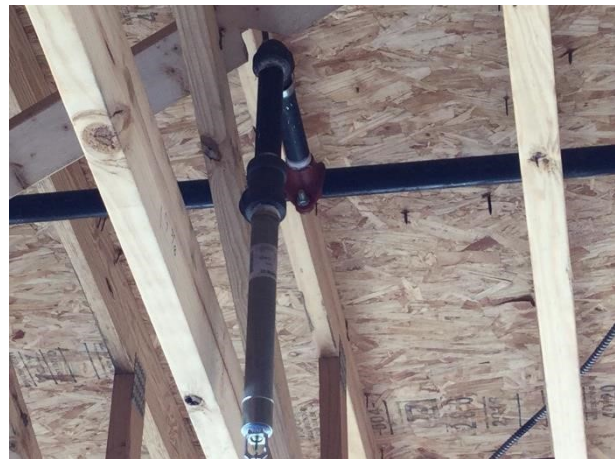
- Failing to comply with the proper installation of dry pendent heads [NFPA 13-8.4.9.1](#). This environment was a non-climate controlled, non-insulated concealed space.

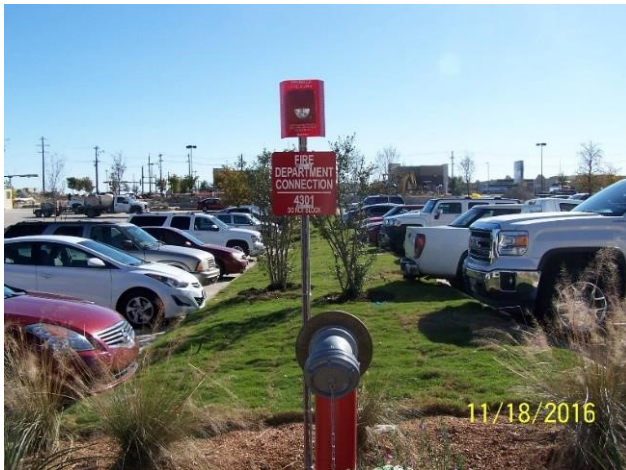
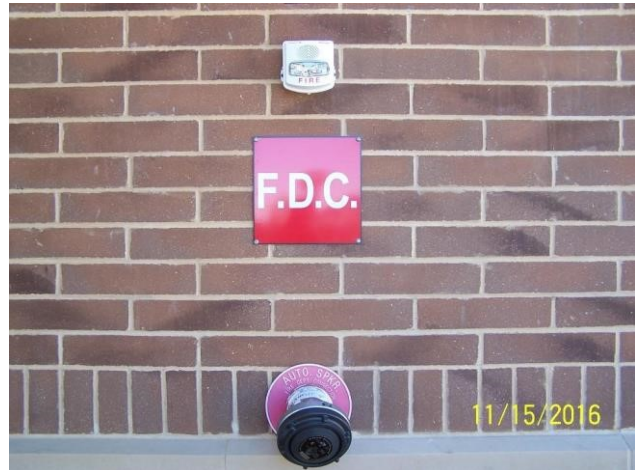
- Failing to install FDC as required by responding fire department - Most departments require a 5 inch (5") Stortz connection with a 30 degree downward turn.

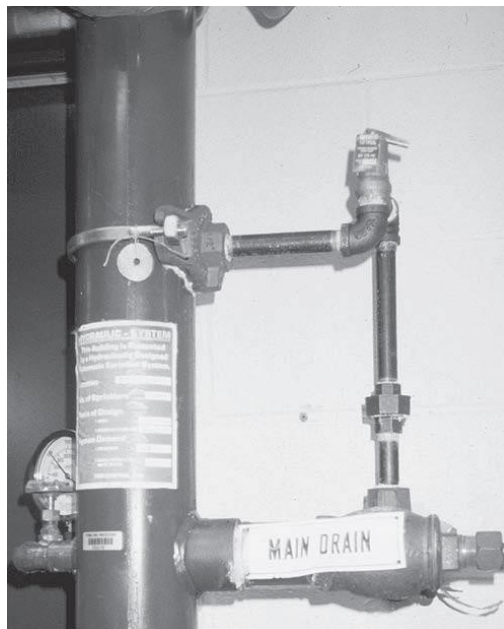
6. Failing to install a pressure relief valve on all wet pipe sprinkler systems - [NFPA 13-7.1.2.1](#)
